Accelerated Potential-induced Degradation (PID) and Recovery of Small PV Module (Glass/EVA/Cell/EVA/BS)

MAJOR FOCUS

- Natural & Artificial Recoveries of Accelerated PID in Small Solar Module

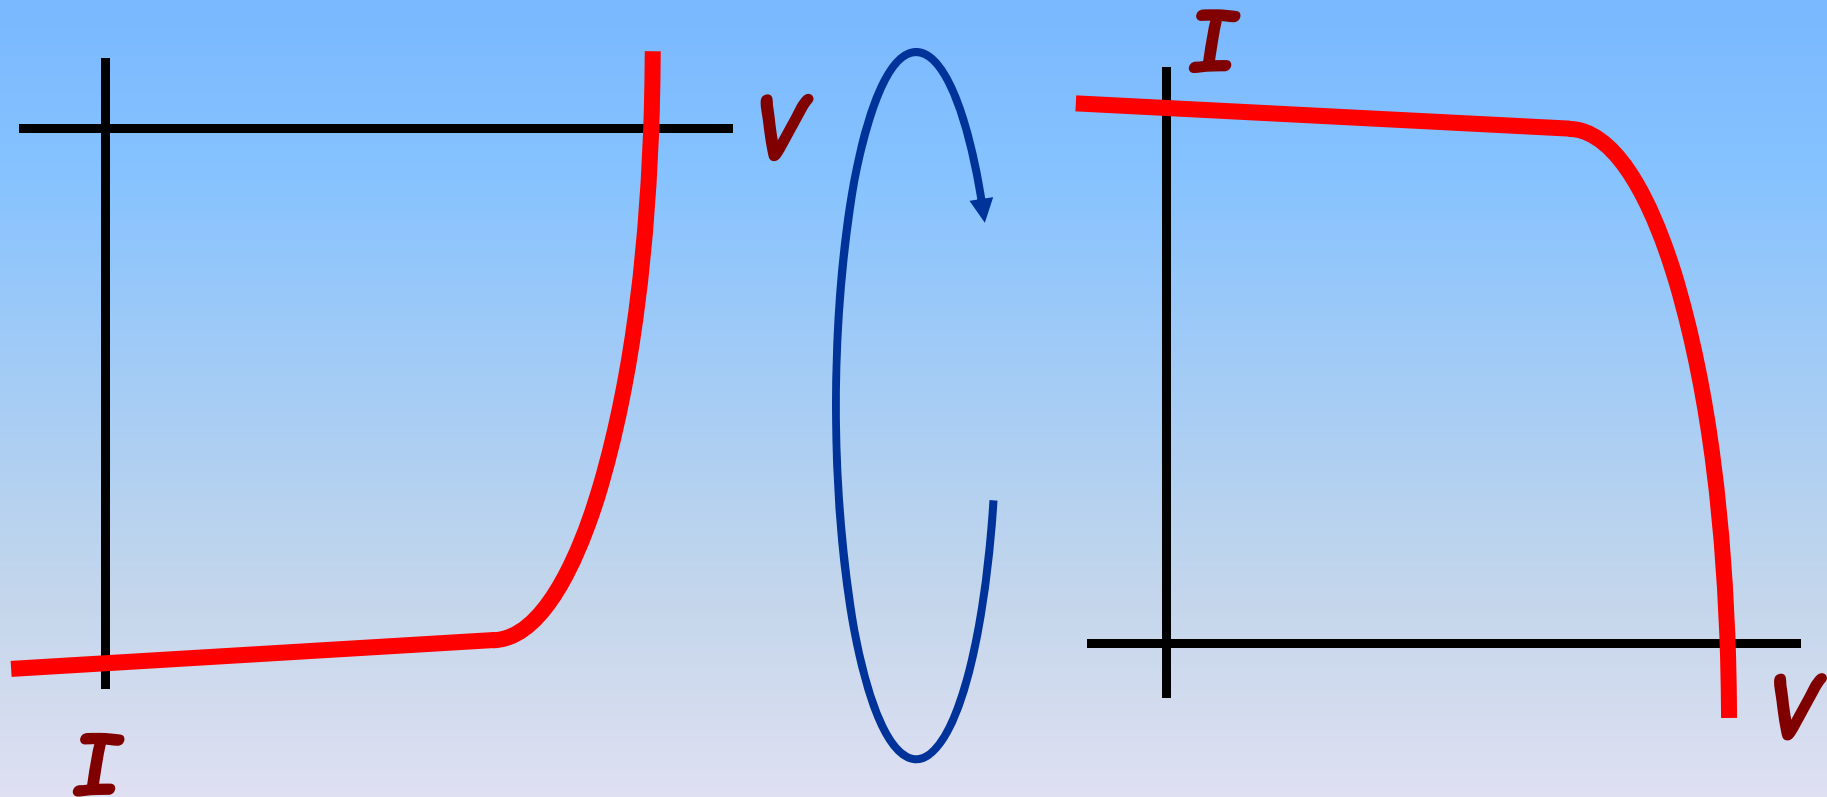
The IV characteristic of a solar cell is usually displayed like this:

The coordinate system is flipped around the voltage axis.

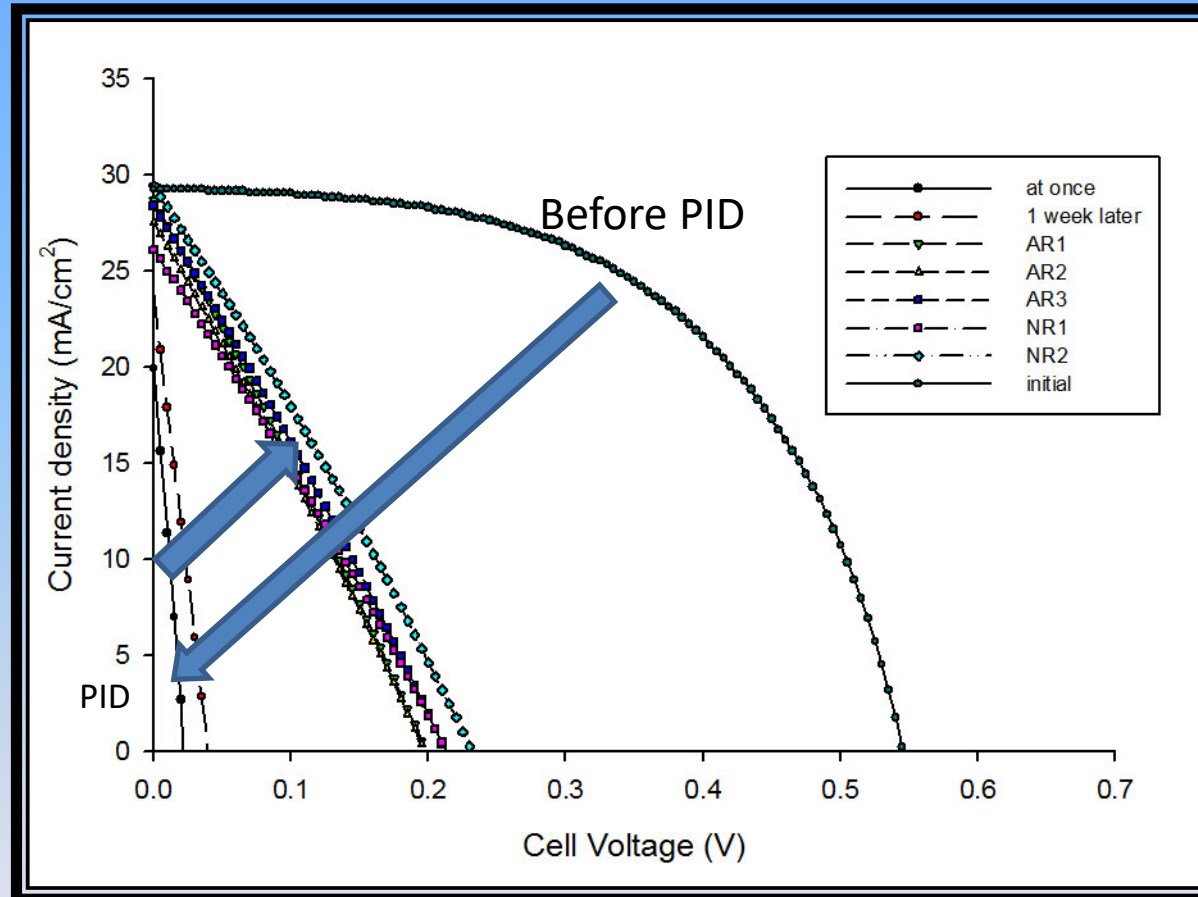
J-V OF INITIAL, DEGRADATION & RECOVERY OF SOLAR MODULE

J-V characteristics of small module (0.91cm²) at degradation, artificial & natural recoveries with initial state

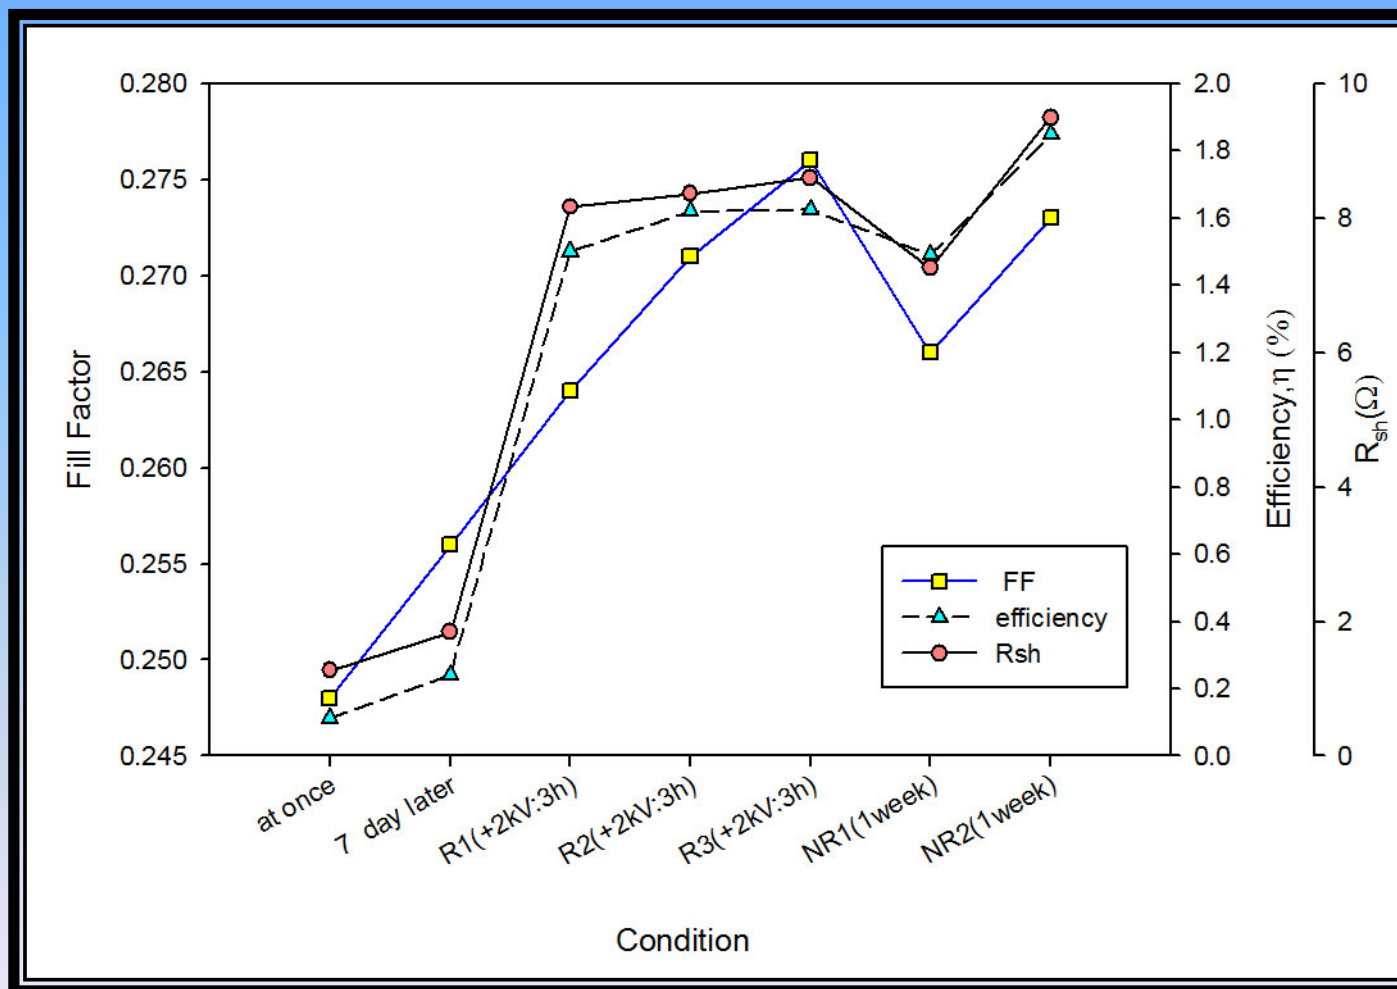
Degradation and recovery condition of solar module

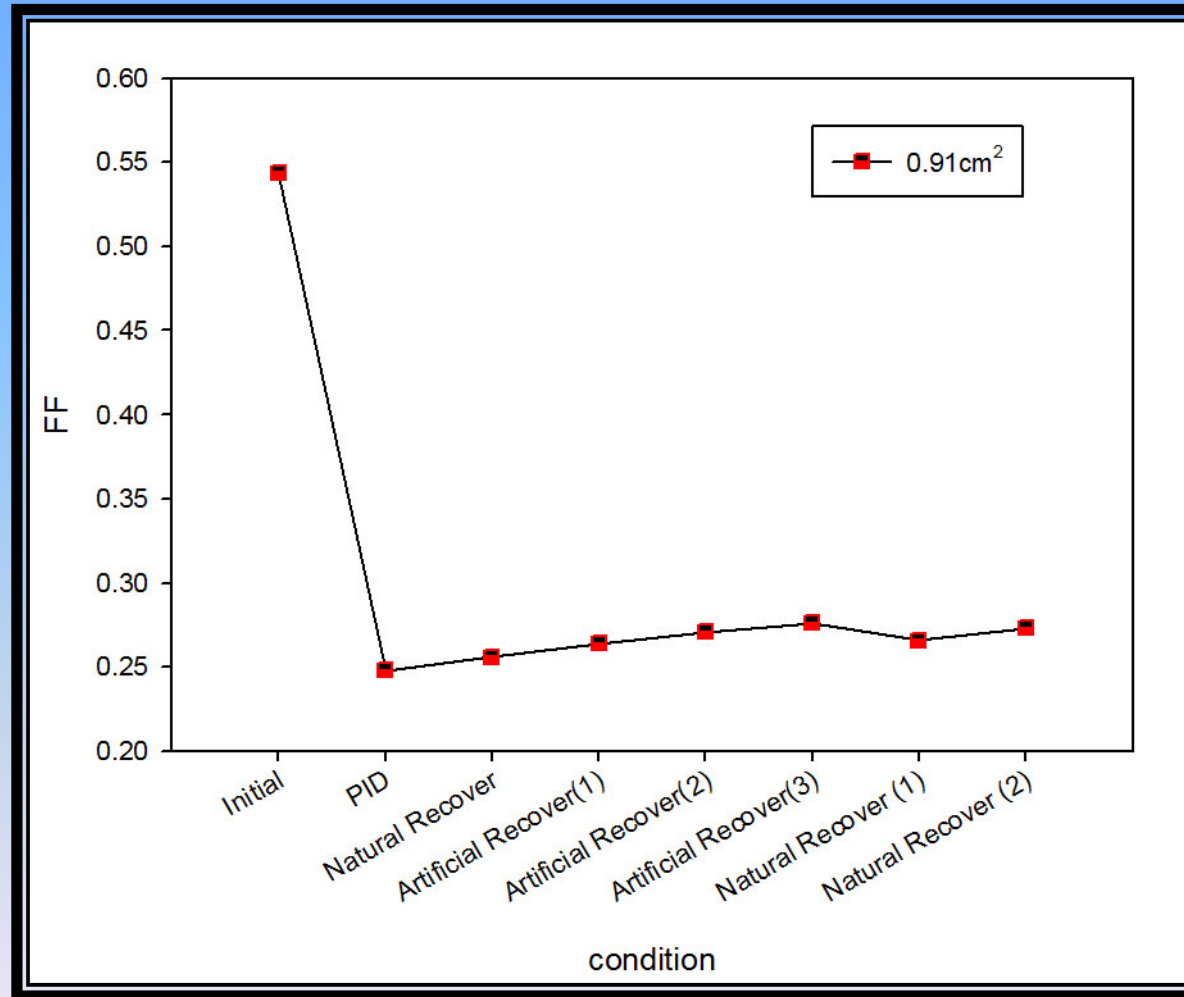
Fill factor of small module (0.91cm^2) at initial state, after PID, artificial and natural recoveries

Condition	FF	Eff(%)	R _{sh} (Ω)
Initial	0.544	8.670	77.551
PID (-2k/6h)	0.248	0.113	1.268
1 week later	0.256	0.238	1.843
AR1(+2k/3h)	0.264	1.5	8.158
AR2(+2k/3h)	0.271	1.618	8.36
AR3(+2k/3h)	0.276	1.623	8.59
NR 1	0.266	1.49	7.256
NR2	0.273	1.847	9.49

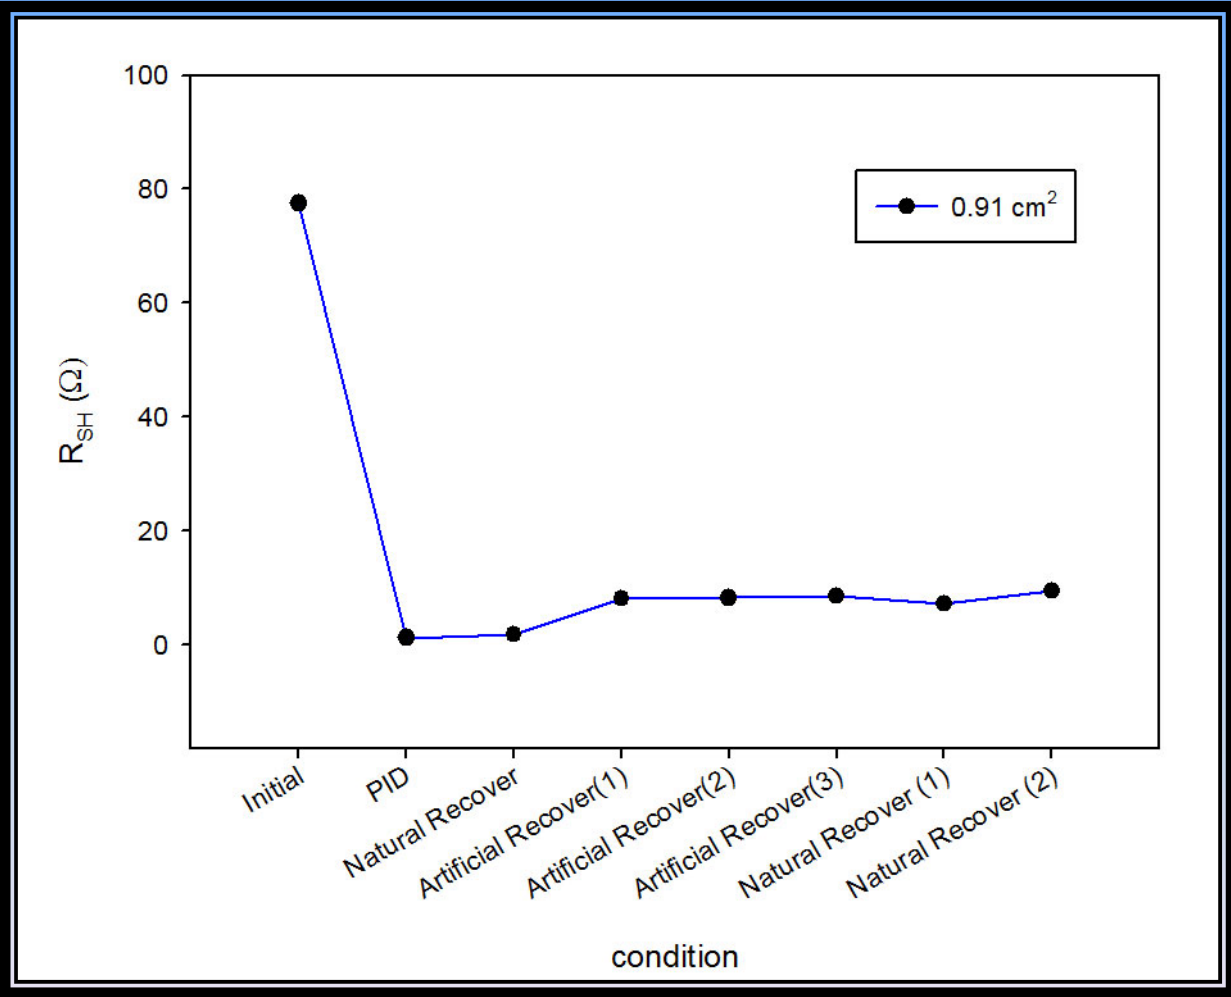
Comparison on shunt resistance of small module at initial state, PID & recovery

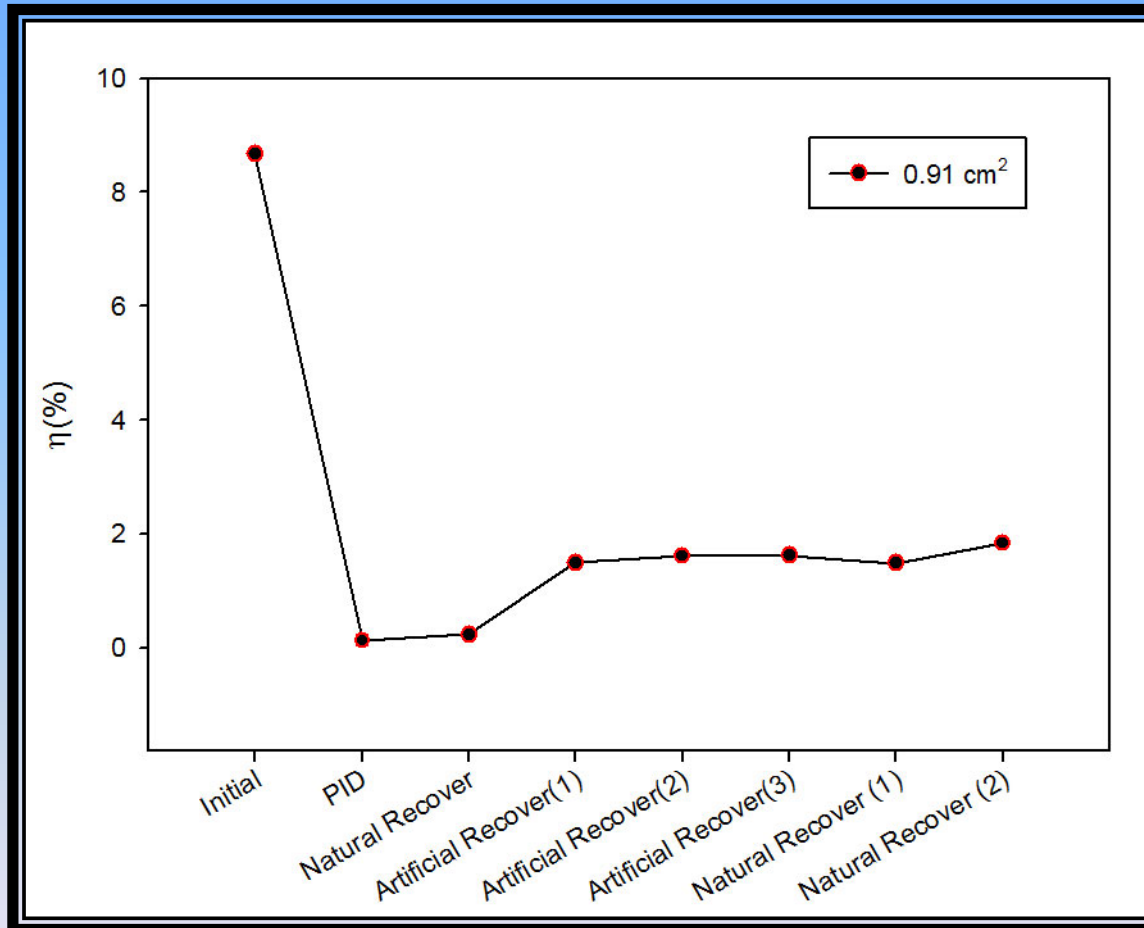
Comparison on fill factor of small module at initial state, PID & recovery

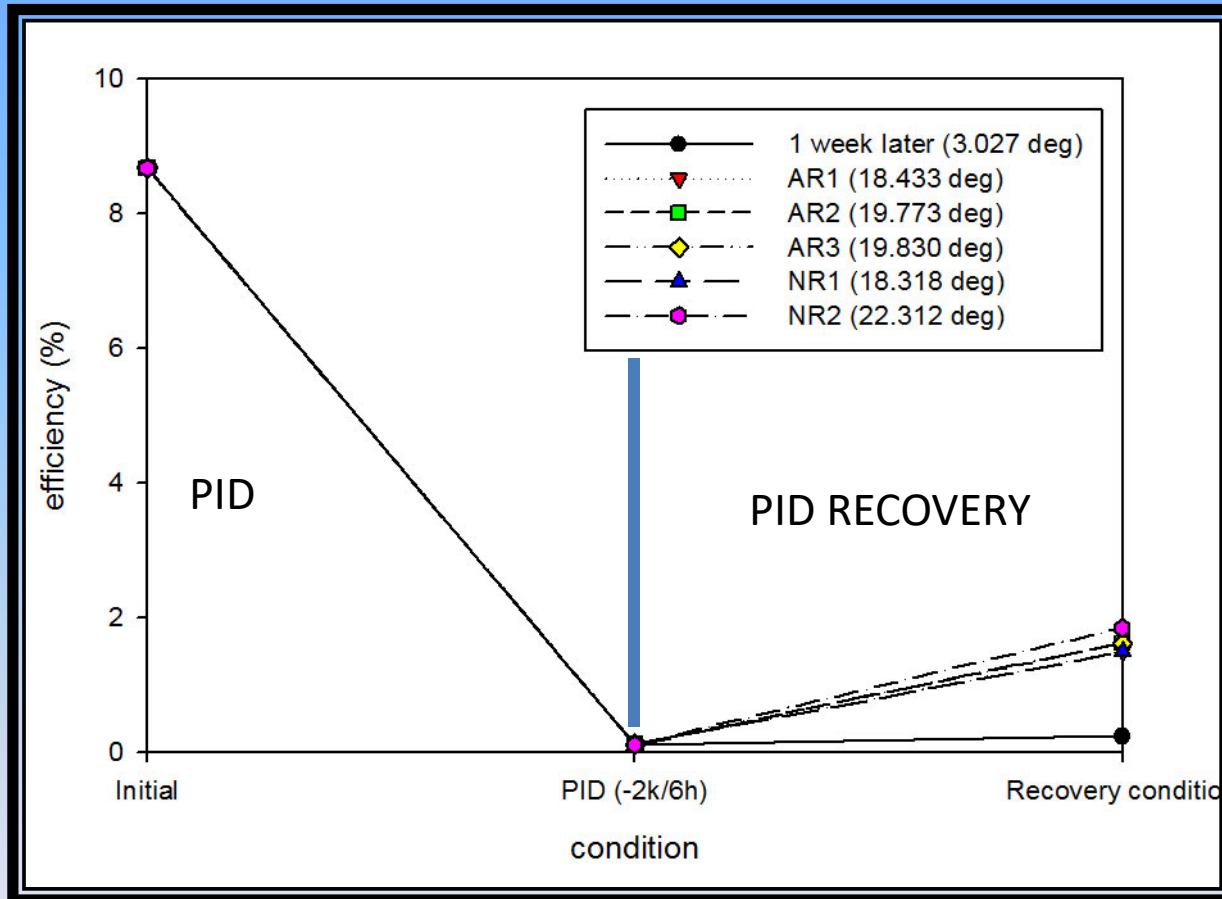
Angle of recovery for efficiency after accelerated PID of SOLAR MODULE

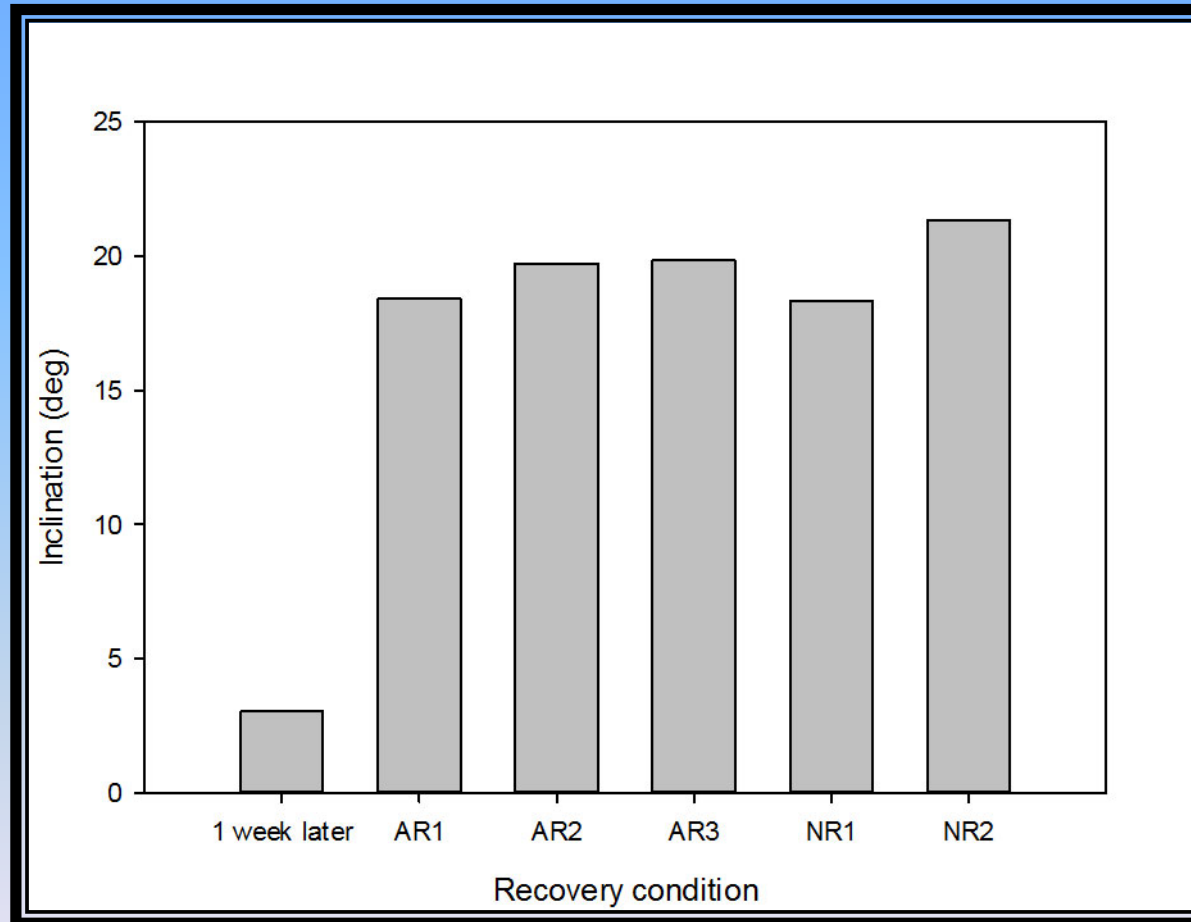
Inclination of SOLAR MODULE at different recoveries
